Jon's 1988 Chevrolet Caprice C91 police vehicle is pristine inside and out.

In November of 2019, I was surfing eBay looking at cars. I do that often in the late night hours, just looking and admiring. But that night I ran across a car that piqued my interest. It was a 1988 Chevy Caprice with the 9C1 police package.

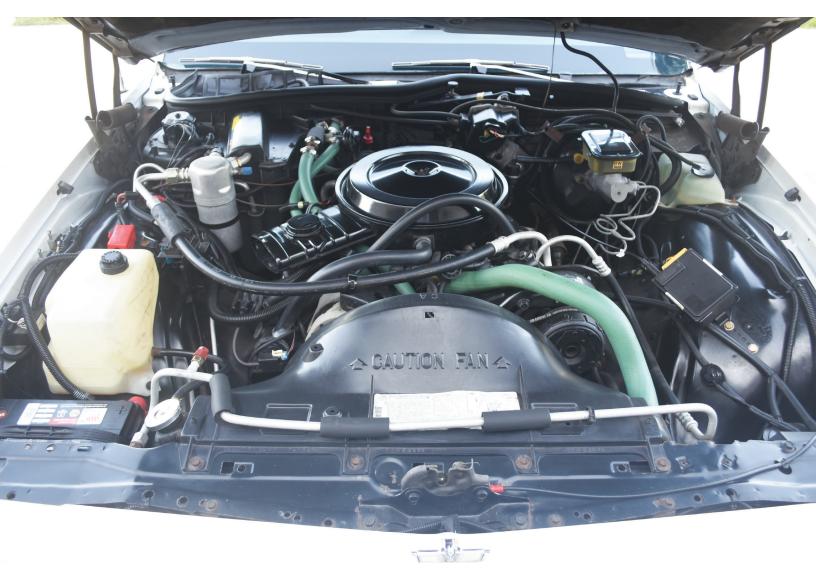
The green radiator and heater hoses are silicon, which are much more durable than rubber hoses. They are believed to be the original hoses.

For some trivia, the under hood photo on page 27 shows the green radiator and heater hoses. These are the original silicon hoses that were an option on the police package. The Crown Victoria police package also used these hoses.

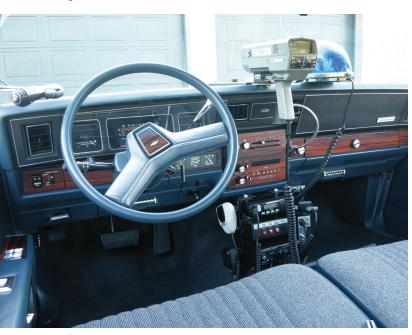
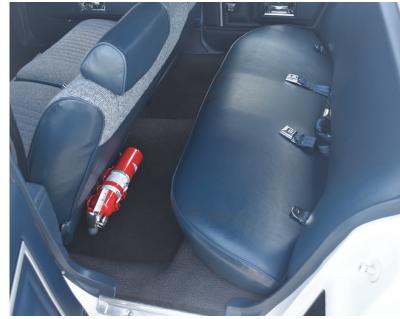
Left to right: Police cars were much simpler in 1988. There are no laptops and no banks of switches to control fancy light bars. All the equipment, including the radar gun, is period correct and functions properly. The police package included a vinyl rear seat for easier clean up. The interior door handles are inoperative, and the doors cannot be opened from the inside.

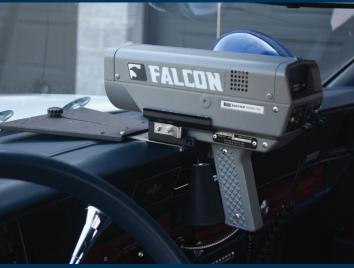
Clockwise from upper left corner: Chevrolet specified the standard features available on their 9C1 Caprice Police Vehicle. There was a multitude of special equipment options available. The special equipment list continues. A photo shows the fully operational Falcon radar equipment.
